INDEPENDENT FORENSIC TEAM REPORT OROVILLE DAM SPILLWAY INCIDENT

JANUARY 5, 2018

Appendix C

General Site Geology, Seismicity, and Site Geological Conditions

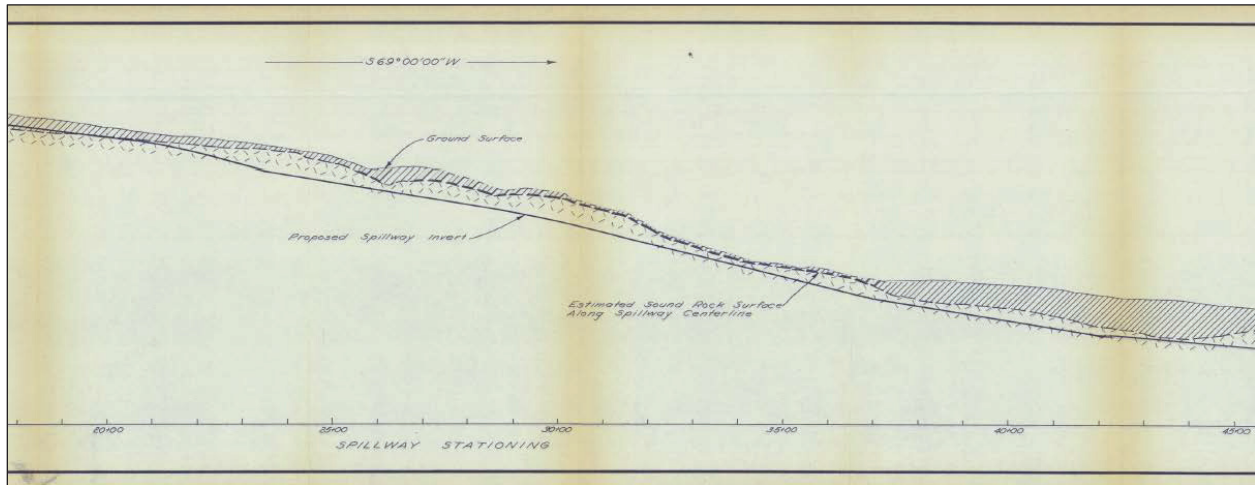
Figure C-5: Portion of a longitudinal section along original spillway alignment, based on 1961 investigations. Now downstream from current emergency spillway.

“Depth to sound rock,” defined similarly to that in the first report, was shown in a longitudinal section along what is now an alignment within the emergency spillway discharge channel. The proposed invert of the spillway on the profile was shown to be excavated down into “sound rock,” or at the top of “sound rock” for its entirety, except for a small portion adjacent to the Feather River. A portion of the profile is shown below in Figure C-5.

This foundation rock had been thought of as acceptable for riprap, and the IFT believes that this is the basis of not having a concrete liner in the original design, as noted later in this appendix.

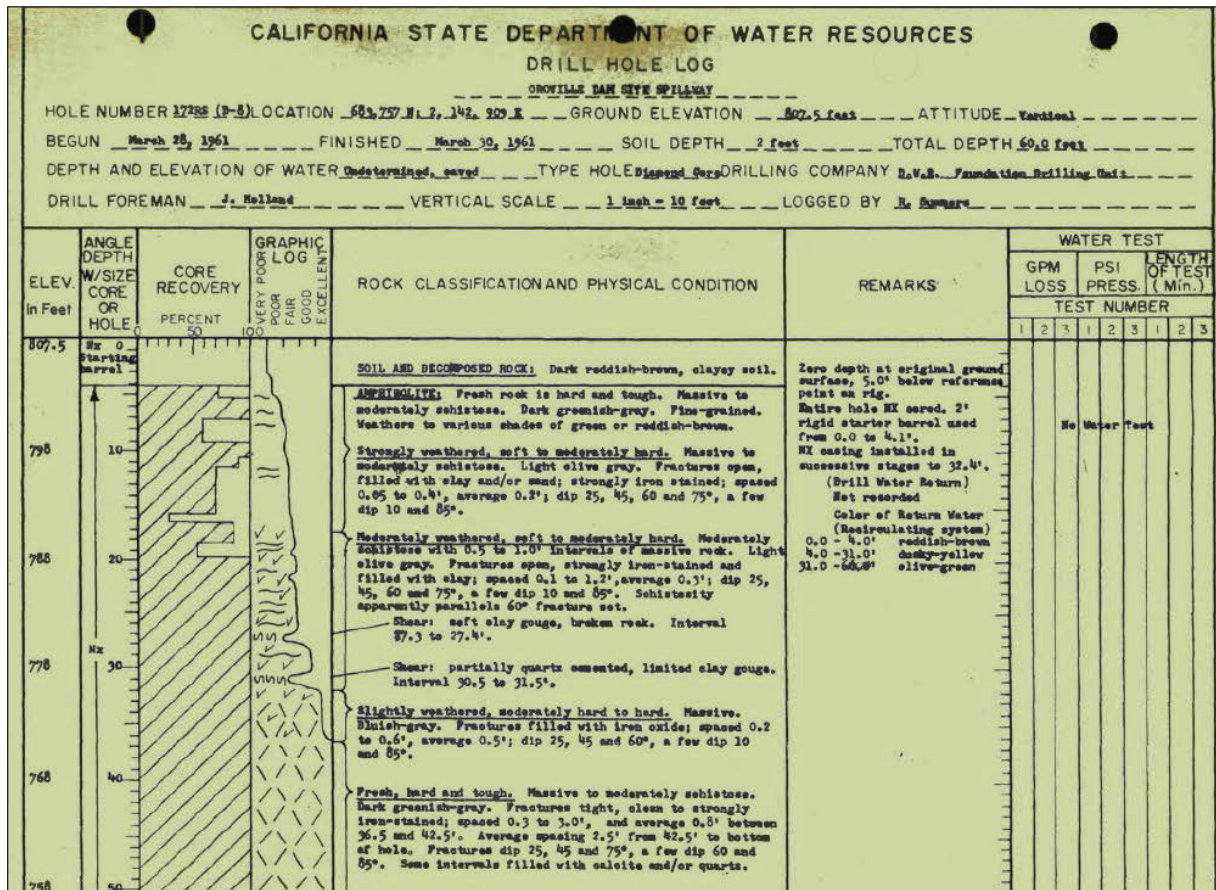
Figure C-6: Borehole 172RS, approximately 500 feet downstream of Emergency Spillway Weir

Although there is a general increase in rock quality with depth, there is great variability in the degree of weathering, jointing, rock strength etc., as would be expected. Rock quality (a product of all these different variables) is thus simply represented in a subjective graphic log.

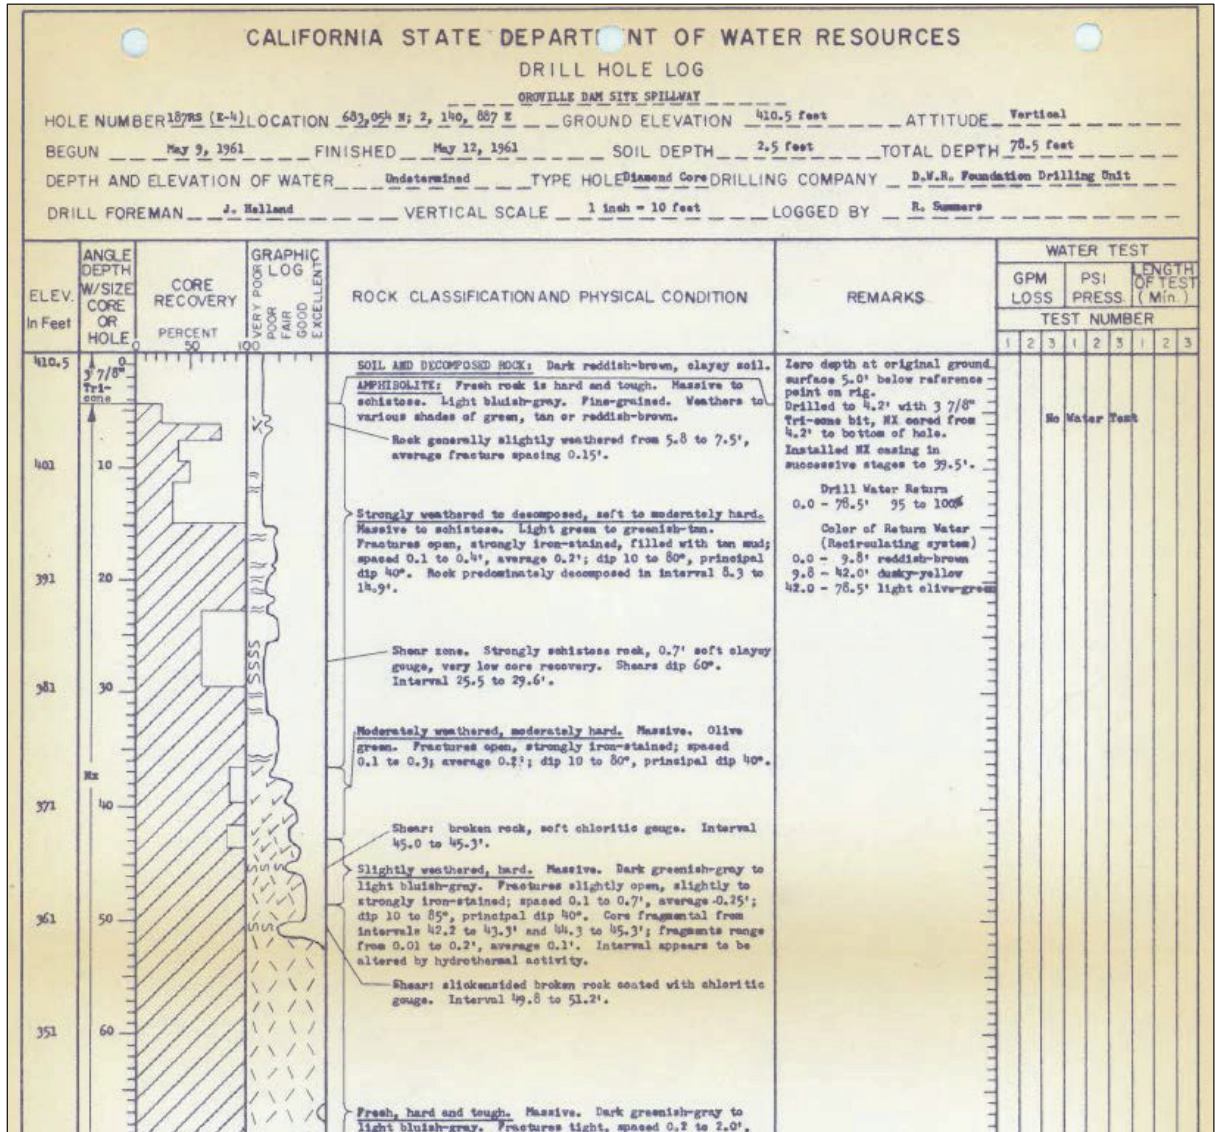
Figure C-7: Borehole 187RS, approximately 2600 feet downstream of Emergency Spillway Weir

In view of the high level of care and detail shown in the production of these borehole logs, it is difficult to believe that these authors did not consider these to be the conditions that they described as “subject to relatively accelerated erosion; where this is critical, the rock should be protected.” As the invert is generally shown to be lower, on or into the “sound rock,” there would be little or no rock requiring protection by a concrete lining. This could be the reason why the 1962 report shows the spillway excavation down into sound rock, and does not expressly address a concrete

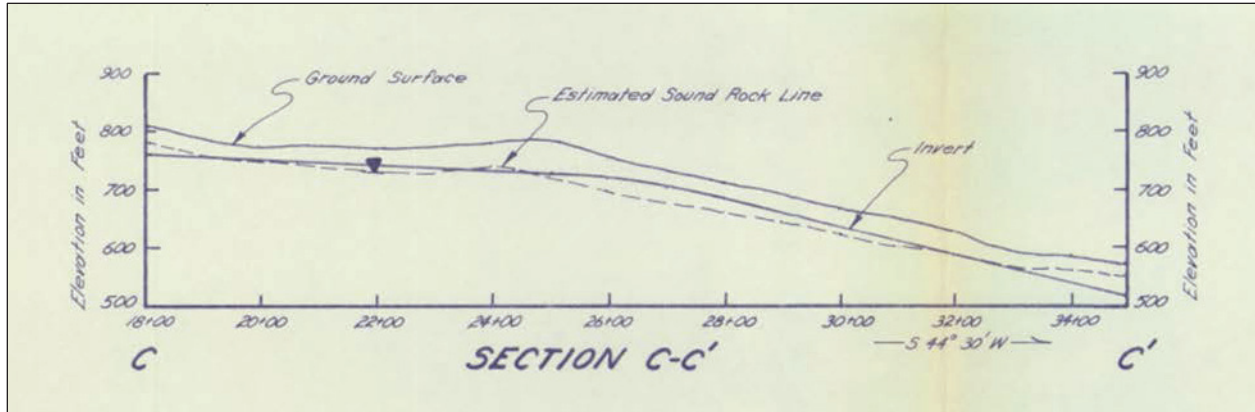
Figure C-8: Portion of a longitudinal section along final service spillway alignment, based on 1964 investigations.

Based on the above information, a profile along the service spillway was developed, a portion of which is given below in Figure C-8. Note that, at the scale of the profiles, the elevations of both "sound rock" and the spillway chute invert as shown do not appear to correlate well with actual design conditions. It is possible that the geologists preparing these sections were not using finalized invert elevations. Also, as the profile was based primarily on drill hole data, in some cases more than 500 feet apart, the "sound rock" profile itself is quite unreliable, including in the area where the service spillway chute failure initiated. However the profiles do indicate what the geologists expected in terms of foundation conditions. In contrast to the 1962 profile along the older alignment, the spillway invert is now shown to be in both sound rock and overlying rock.

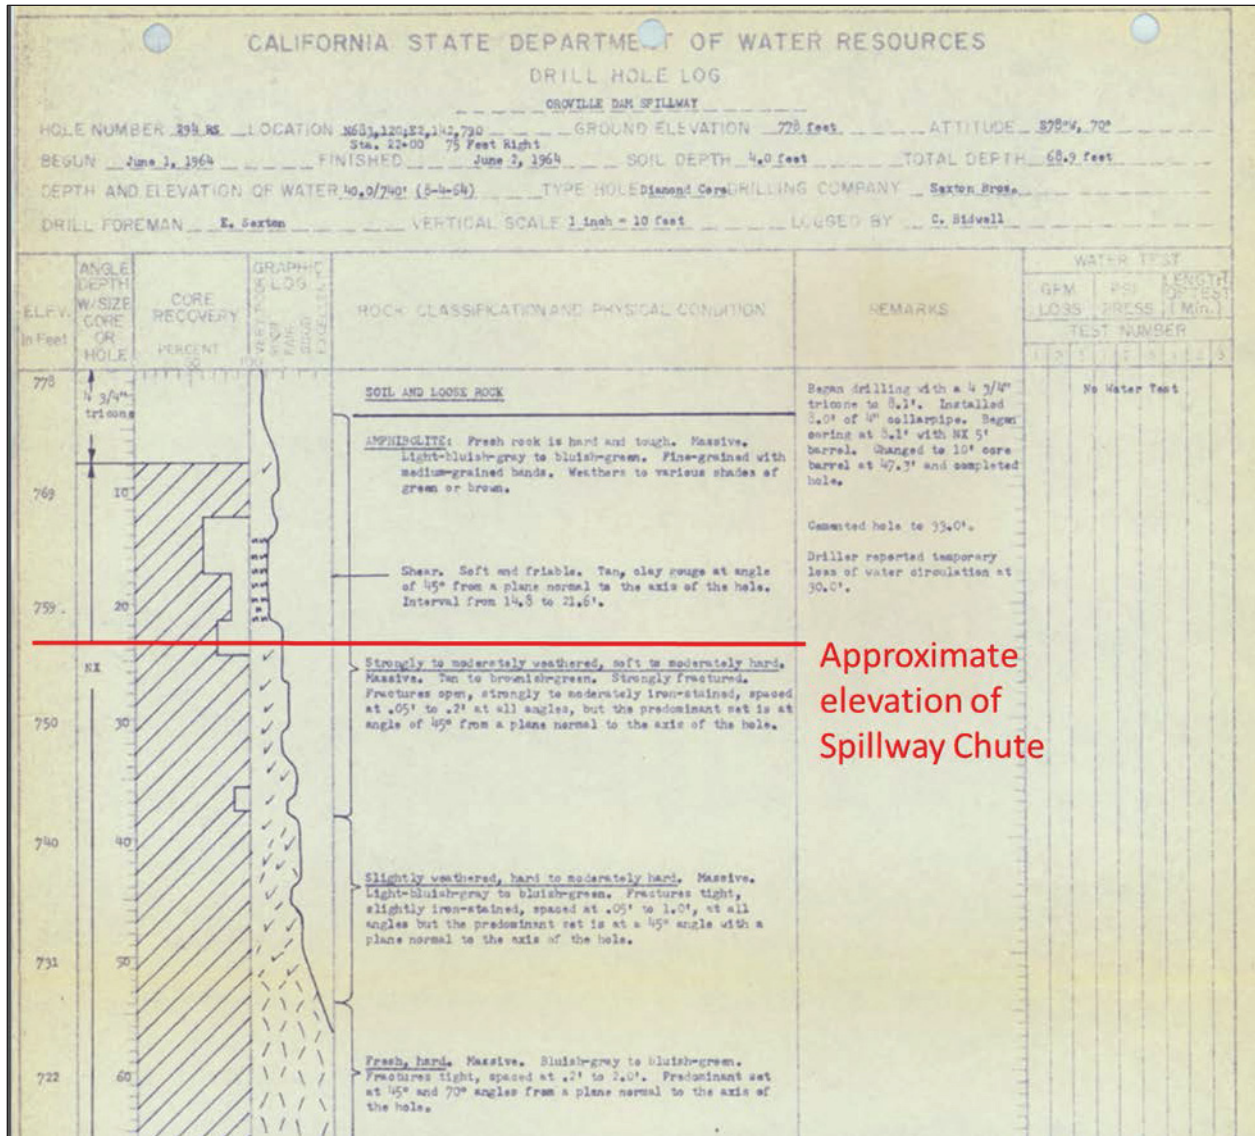
Figure C-9: Borehole 294RS, approximately Sta. 22+00 along Service Spillway, offset 75 feet

The detailed borehole log for 294RS, located closest to this area, is given in Figure C-9.

Although rippable conditions were called out in the report, apparently associated with strongly to moderately weathered rock of poor to fair quality (as per Figure C9), apparently no special treatment for such fully rippable foundations was considered, and the following general statement was given:

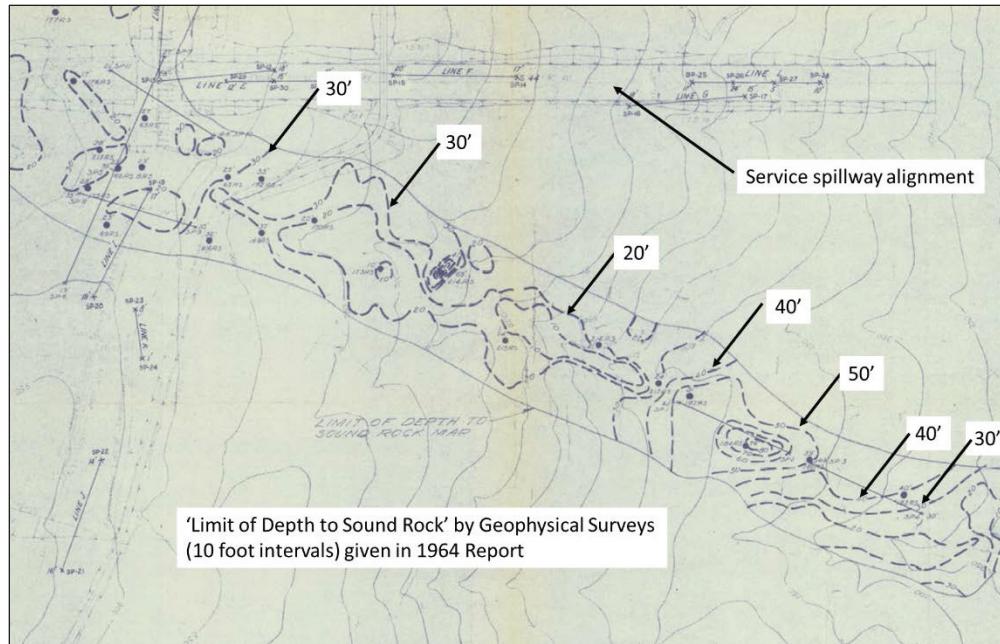
Figure C-10: Summary of 1961 Geophysical Results downstream from current emergency spillway weir

This summary shows large depths to sound rock, as defined for the purpose of riprap exploitation. The relevance to the current discussion is that the report indicates that there was no discernable difference in velocity from the surficial soil and decomposed rock layer until the “sound” rock layer was reached in most surveys, i.e. the measured velocities of the moderately to strongly weathered rock were not different enough from the measured velocities of the soil and decomposed rock to be interpreted as a separate layer. This would be yet another indication that significant depths of erodible material could be expected downstream from the emergency weir.

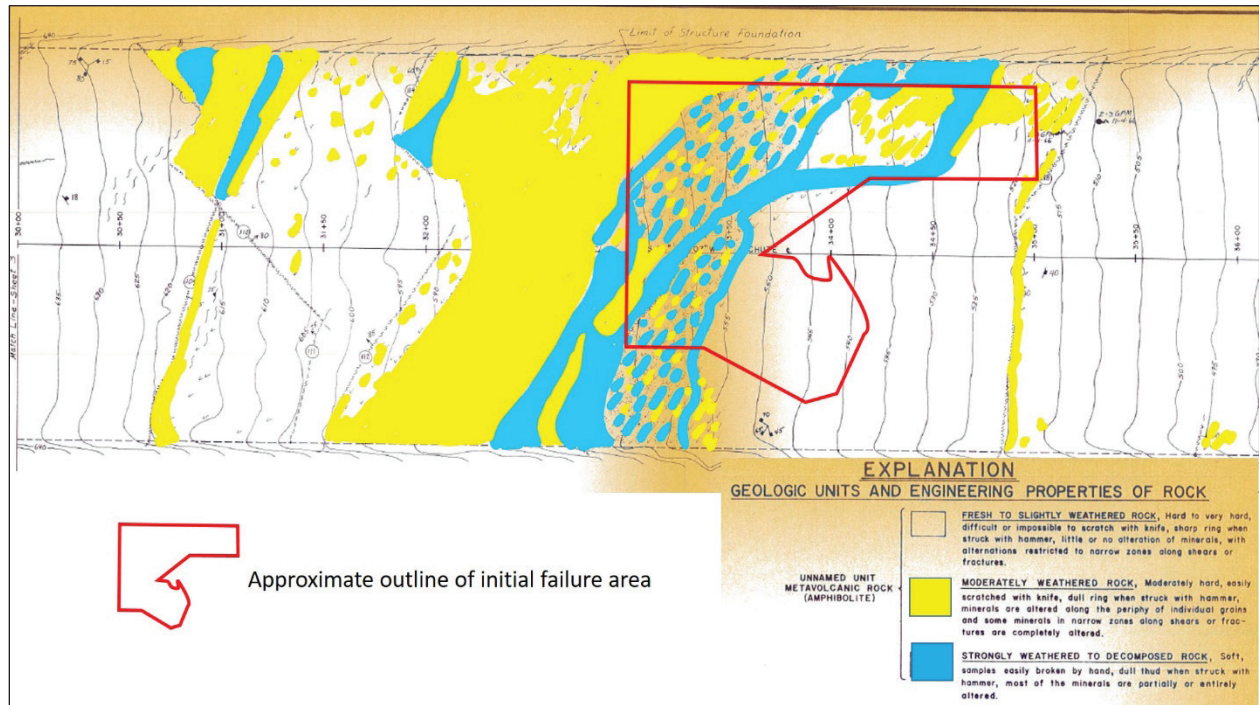
Figure C-11: Extents of Moderately and Strongly Weathered Rock. Geologic mapping from Final Geologic Report [C-1]

There is no moderately or strongly weathered rock noted in the foundation for the first 600 feet downstream from the headworks structure. The most upstream locations where such conditions were found are documented on the right side of the chute near Sta. 19+00 to 20+50, followed by an area on the left side at Sta. 27+00, with the largest areal extents from Sta. 31+00 to 38+00, in the area of the initial failure in February 2017. Figures C-11 and C-12 are excerpts from drawings in the Final Geologic Report showing the large extents of the moderately and strongly weathered rock, and the degree of compacted clayey fines left upon foundation cleanup in the vicinity of the initial spillway slab failure (colorized by the IFT). These aspects are discussed further in Appendix I.

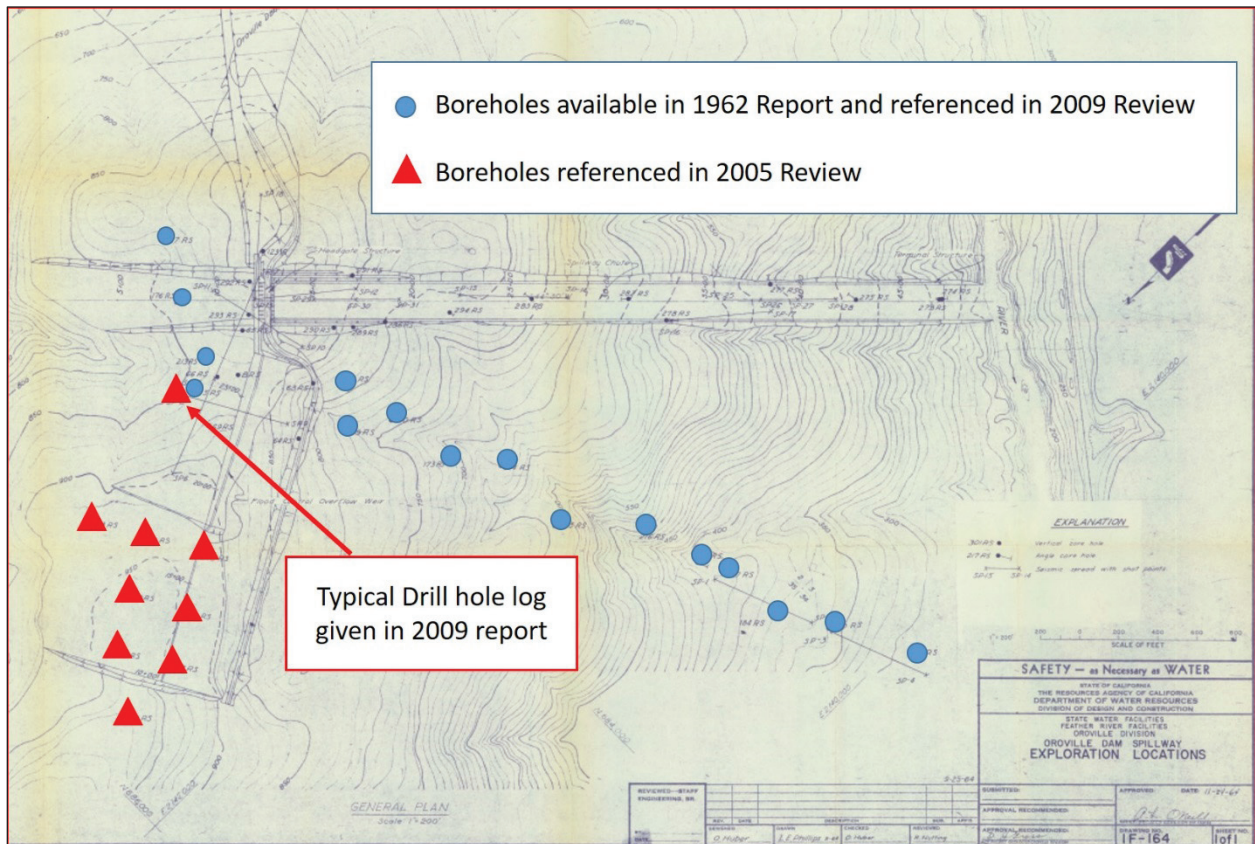
Figure C-13: Borehole Logs Available for Review

“The attached drawing contains summary drill hole logs for some important drill holes. We could not find the actual drill hole logs, just this sheet.”

Thus, the detailed geological descriptions that would have given critical information on strength and jointing (which would have indicated the likelihood of erodibility) downstream from the emergency weir were not accessed. However, the nine borehole logs that were accessed provided ample evidence of poor to very poor rock conditions. Even if one assumed that moderately weathered rock was non-erodible, six of the nine logs show worse than moderately weathered rock conditions. Two logs show strongly weathered rock to depths of 12 feet and 17 feet, and all six logs indicate moderately to strongly weathered, moderately weathered to soft, poor to fair conditions to depths ranging from 22 Feet to 44 feet.
