The Mercury News

Oroville Dam: Water flows slow, reducing likelihood emergency spillway will be used

*By Paul Rogers | progers@bayareanewsgroup.com and Jason Green | jason.green@bayareanewsgroup.com
PUBLISHED: February 9, 2017 at 10:05 pm | UPDATED: February 10, 2017 at 2:18 pm*

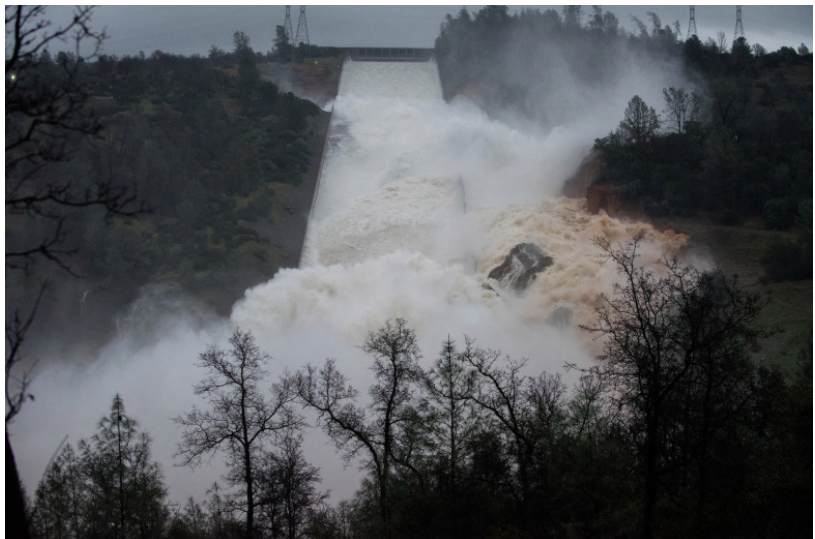
The California Department of Water Resources and host of collaborating agencies continue to monitor the Lake Oroville spillway flows late Thursday afternoon as 35,000 cubic feet per second (cfs) of water was released over the damaged spillway. More erosion is expected, but the releases will help operators absorb the inflow of the storm waters expected Thursday evening and Friday. DWR first noticed erosion on the spillway Tuesday morning and shut off flows to investigate. (Courtesy of the California Department of Water Resources)

But by mid-day Friday, engineers were releasing 65,000 cfs down the damaged regular spillway, slowing the lake's rise just enough to prevent that. The torrent of water — roughly 486,000 gallons a second, or the volume of an Olympic swimming pool every two seconds — turned the broken spillway into a raging waterfall.

Officials said they expected the cavity to widen as a result — and it did. One photo circulated online showed water crashing into the now 45-foot deep hole, leaving the spillway and flowing down the hillside. The dramatic scene spurred speculation the structure had failed.

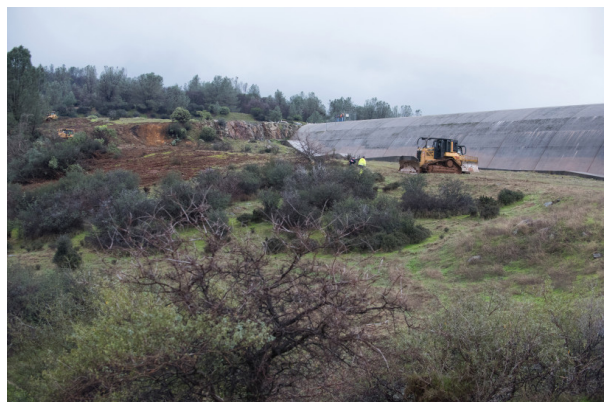
The California Department of Water Resources is preparing a contingency plan for the potential use of the Lake Oroville emergency spillway, as DWR clears trees, rocks and other debris from the hillside near the dam where water would flow. Approximately 50 to 100 acres of trees and brushes could be affected by water releases. The removal would reduce the potential debris flow into the diversion pool and Feather River in Butte County. (Courtesy of the California Department of Water Resources)

If conditions change, and the reservoir exceeds its maximum capacity of 3.5 million acre-feet, water will pour down the emergency spillway. In recent days, Cal Fire crews have been tapped to clear up to 100 acres of trees and brush between the concrete lip of the emergency spillway and the river. The Department of Water Resources is also taking measures to protect young salmon and

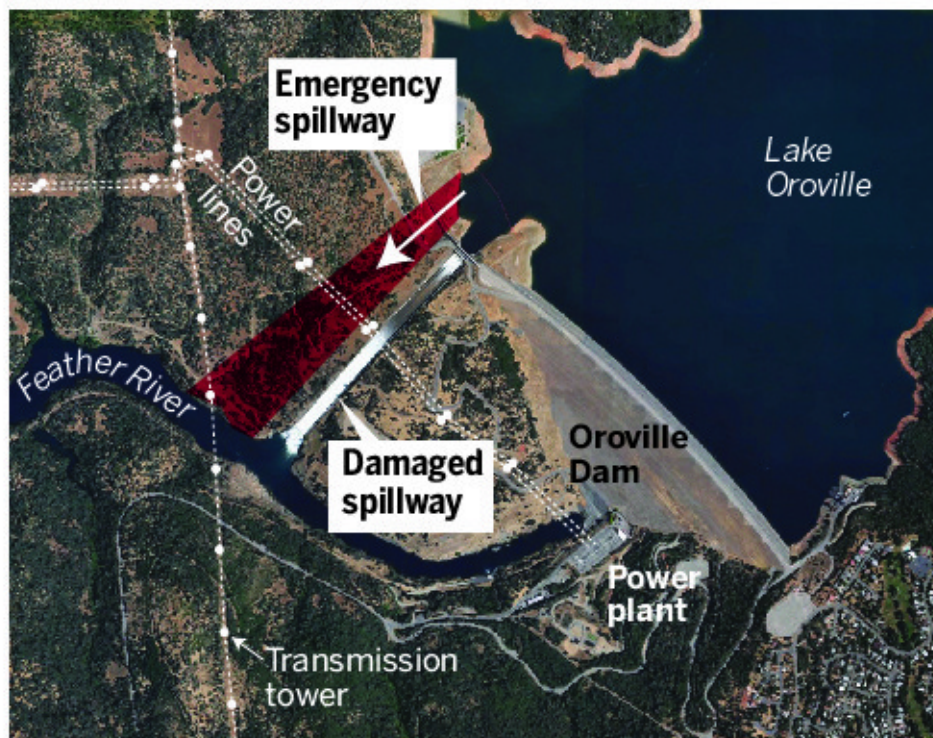
USING THE EMERGENCY SPILLWAY

Because of the damaged concrete spillway at Oroville Dam, excess water may be released via an emergency spillway. This spillway is a last resort, because water rushing down its unprotected hillside would send rocks, trees and debris into the Feather River.
