INDEPENDENT FORENSIC TEAM REPORT OROVILLE DAM SPILLWAY INCIDENT

JANUARY 5, 2018

Appendix C

General Site Geology, Seismicity, and Site Geological Conditions

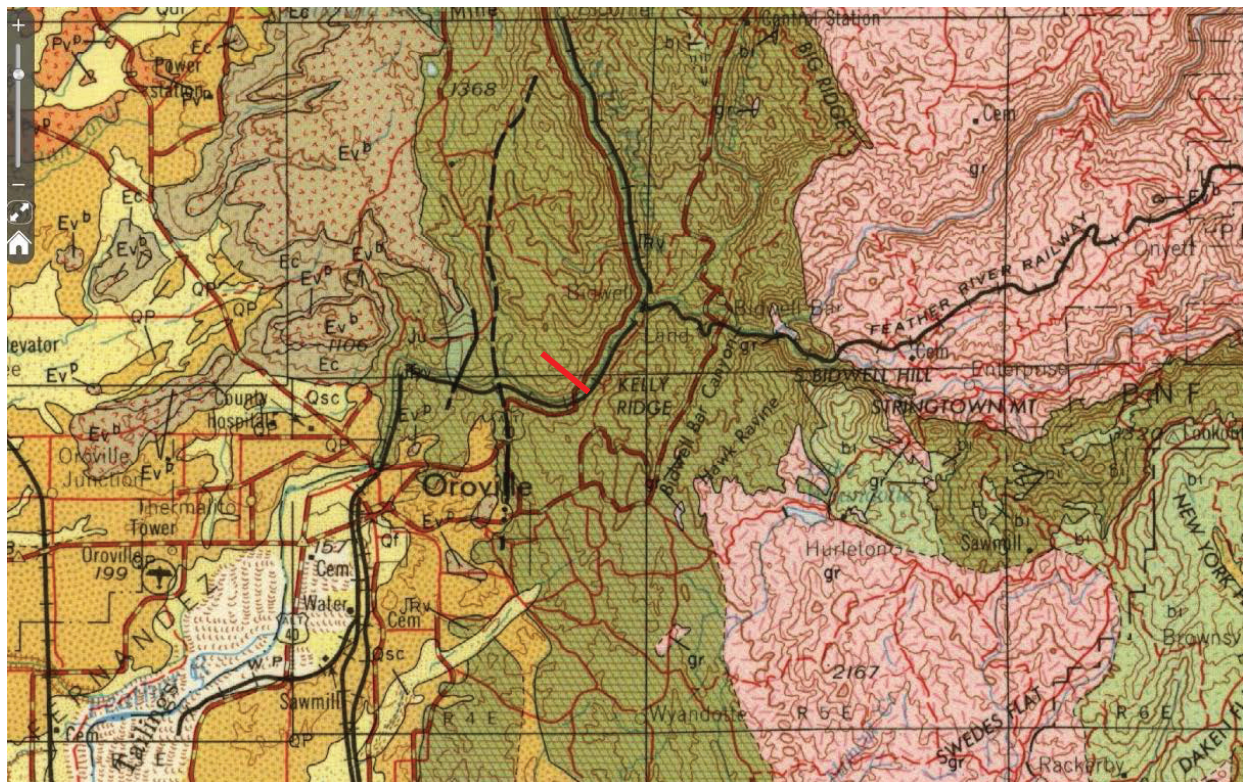
One of the earliest geologic maps of the region was published by California Division of Mines and Geology in 1962 (see Figure C-1). This map shows bedrock at the dam site and spillway areas to be undifferentiated Jura-Trias metavolcanic rocks.

Figure C-1: Enlarged portion of the Chico Quadrangle Geologic Map [C-2], approximate location of Oroville Dam shown by red line

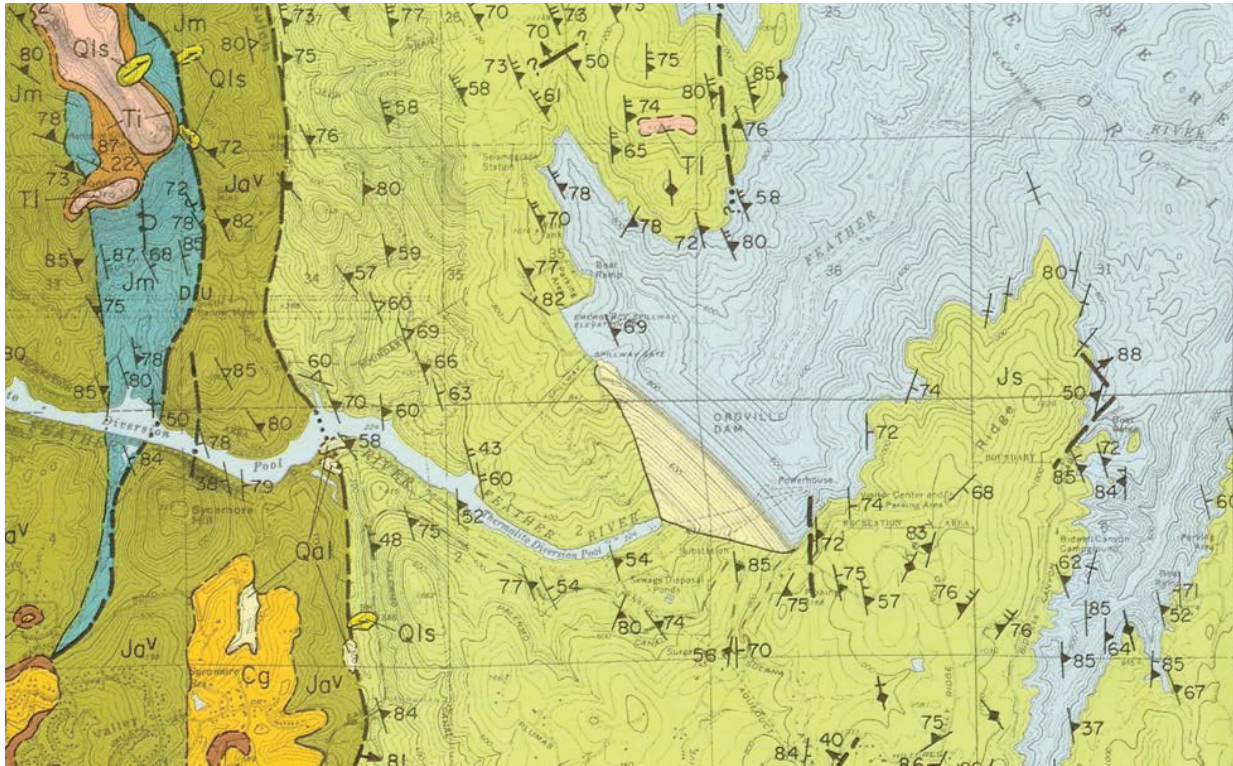
Figure C-2: Enlarged portion of the geologic map of Cole & McJunkin (1978)

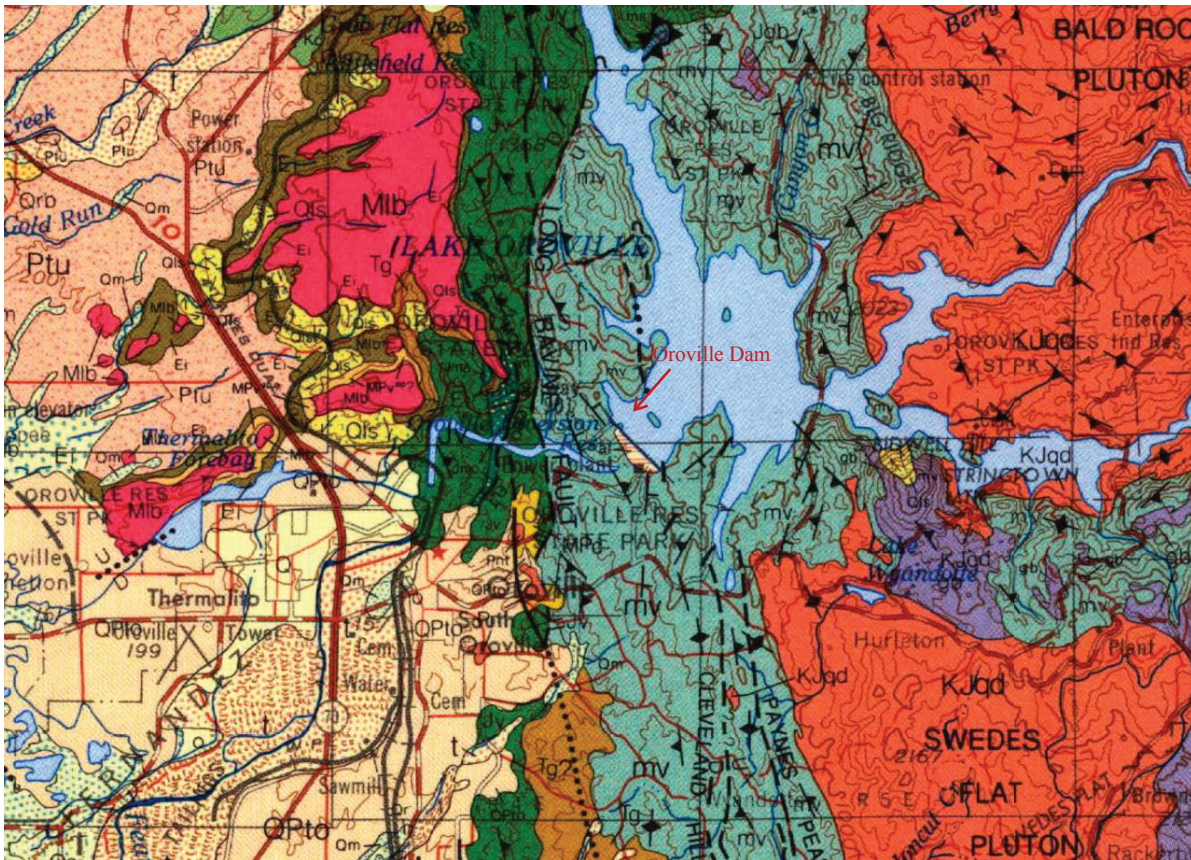
Figure C-3: Enlarged Portion of the Chico Quadrangle Geologic Map^{C-6}

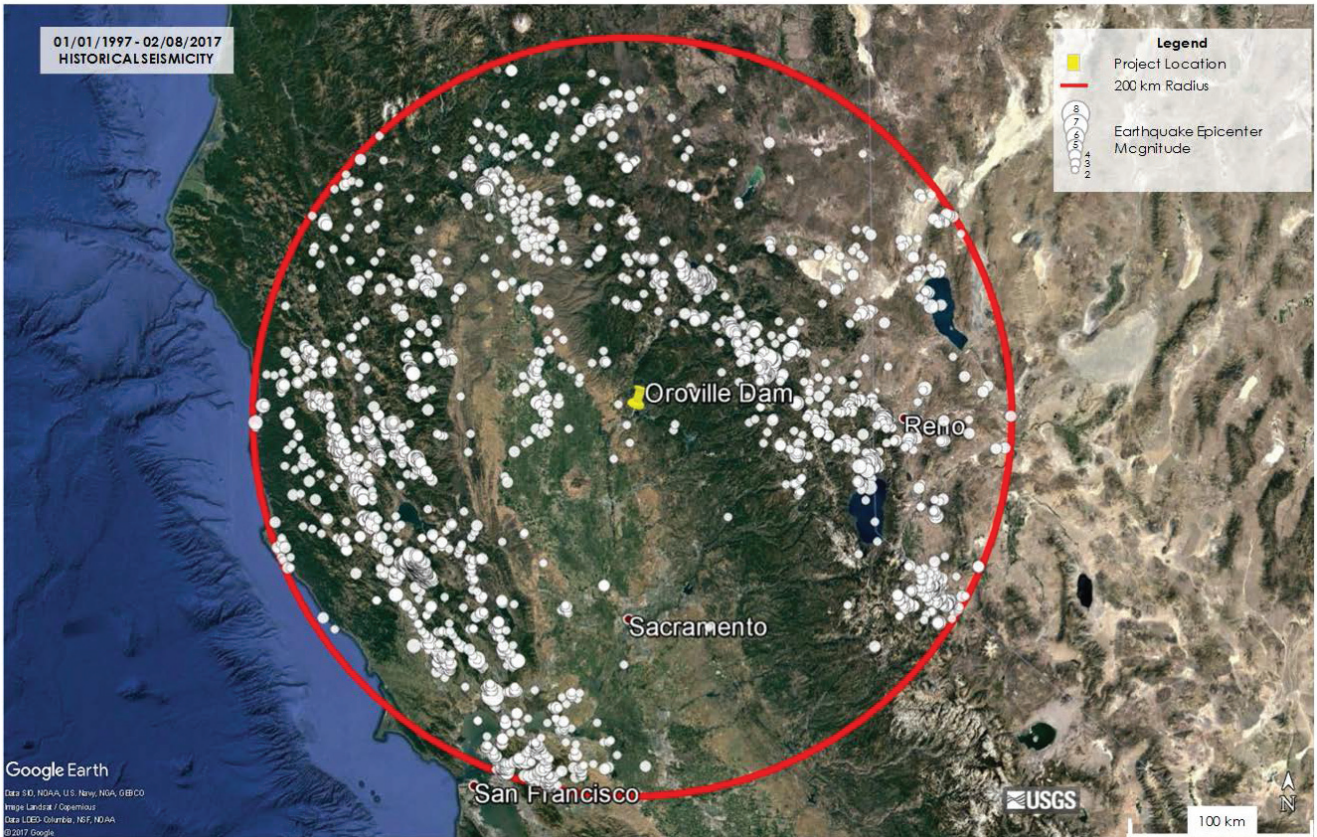
4. A plot of earthquakes ($>M=2.5$) recorded in the last 20 years and within 125 miles (200 km) of the project is provided in Figure C-4. The data set includes seven events $M 4.0$ to $M5.7$ but each was located more than 100 miles from Oroville Dam. The remainder are all

<M4.0. These earthquakes occurred during the timeframe when previous historical major flows had taken place over the spillway. In other words, no new potential damage caused by seismicity had taken place in the time between previous major spillway releases and the February 2017 spillway flows.

Figure C-4: Plot of earthquakes (>M=2.5) recorded in the last 20 years and within 125 miles (200 km) of Oroville Dam. Data from USGS Search Earthquake Catalog [C-12].
