The Sacramento Bee

What went wrong at Oroville Dam? Analysis points to drainage, problematic soils

By Dale Kasler
April 25, 2017 7:29 PM

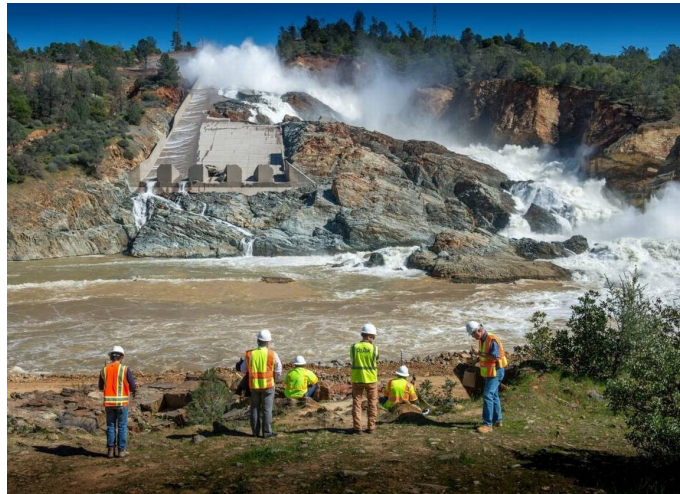
State workers check on the flow of Oroville Dam's battered main spillway in mid-March. A preliminary analysis by the U.S. Army Corps of Engineers cites the presence of substandard materials beneath portions of the spillway, problems with the underlying drainage system and other woes as possible causes of the spillway's fracture. Hector Amezcua hamezcua@sacbee.com

The presence of compacted clay instead of solid rock beneath portions of the concrete chute helped undermine the structure. The underlying drainage system didn't function properly and the steel bars anchoring the spillway to the rock were too short, the Army Corps group concluded.

“When the spillway gates were opened, high velocity water probably entered the cracks and the stagnation pressures were enough to lift and break the thin slabs, given that the anchor bars were short and anchored into weak materials, and there was no steel mat on the bottom of the slab to resist bending,” the Army Corps group wrote.
