# The Oroville Dam 2017 Spillway Incident

And Lessons from the Feather River Basin

## EXECUTIVE SUMMARY

September 2017

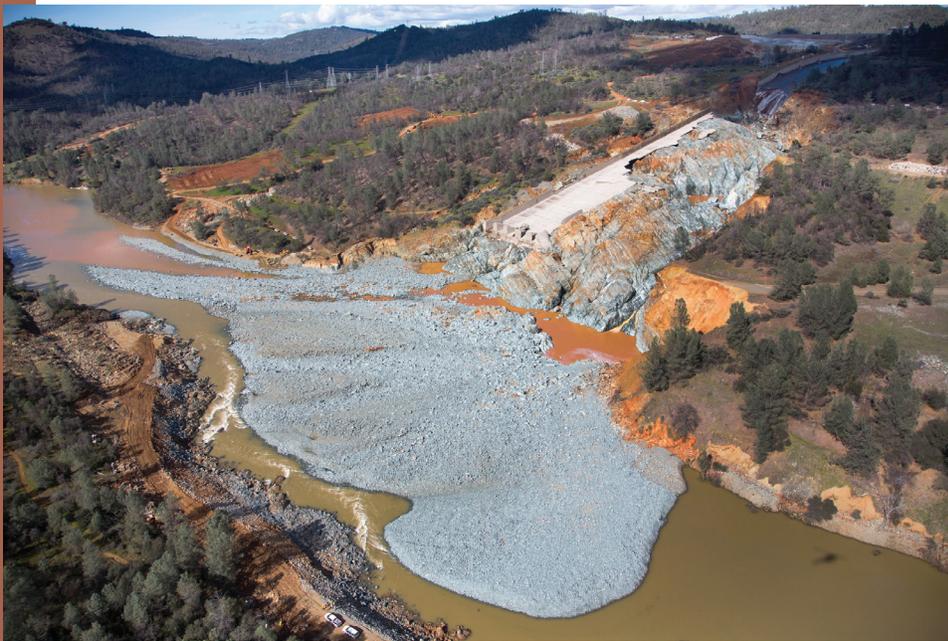
Debris in the Feather River below Damaged Main Spillway. Source: Dale Kolke, DWR.

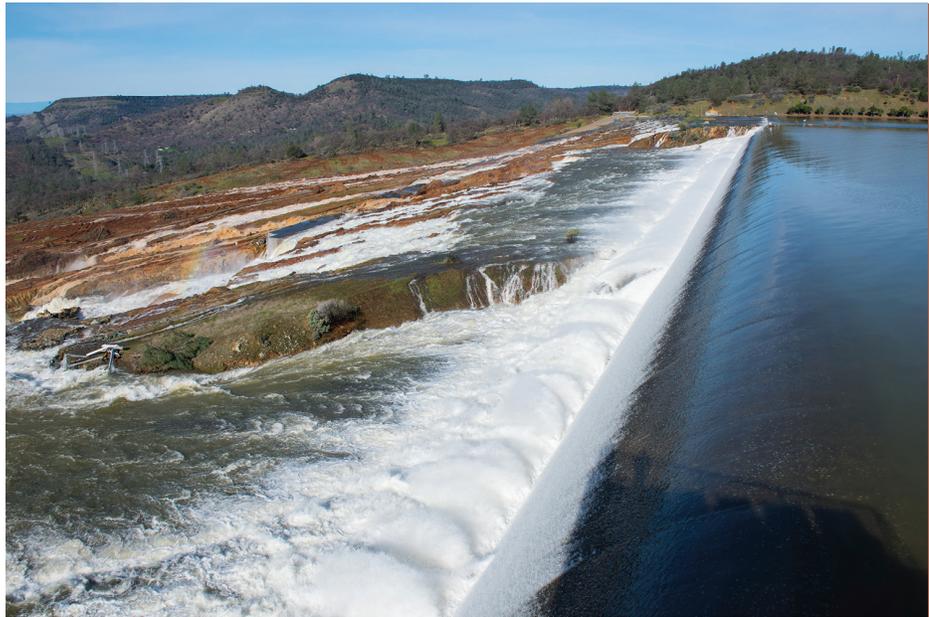
**Emergency Spillway Flows and Erosion, February 12, 2017.** Source: Kelly M. Grow, DWR.

A chief recommendation is the need for a complete emergency spillway at Oroville Dam. Such a facility would have prevented the near catastrophe and the evacuation of thousands of people. At this time, there is no evidence that the Department of Water Resources plans to address this fundamental problem. The report also identifies several other water infrastructure projects in California that may require investment in maintenance, repair or reconstruction. These include Clifton Court Forebay,

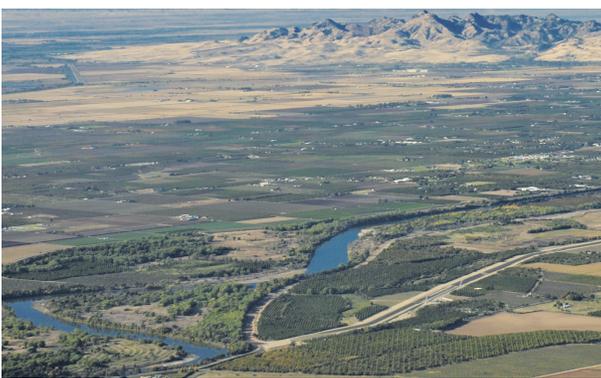
**The Feather River Setback Levee.**  
Source: Eric Ginney / Zeke Lunder.

The report has several recommendations for multi-benefit flood management projects to reduce downstream risk in the event of flooding or infrastructure failure. Funding the Central Valley Flood Protection Plan is critical to implementing several of these projects. The most important of these projects include the expansion of the Yolo Basin Bypass and the Sacramento Bypass. They also include upgrades of the weirs that allow flood flows in the Feather River/Sutter Bypass and American River to enter the Yolo Bypass. Other Sacramento Basin priorities include expansion of the floodplain in the Oroville Wildlife Area and the implementation of the Lower Feather River Corridor Management Plan. In the San Joaquin Basin, reservoir-based floodwater management is far less reliable than in the Sacramento Basin. This problem will only get worse as precipitation patterns shift with climate change. Key projects there include setback levees and a San Joaquin River floodwater bypass in the lower Delta.
